Federal Lead Smelter - East Side
LPC# 1190105308/1191155020
Madison County
SF/HRS

CERCLA Site Investigation

Title: CERCLA Site Investigation for Federal Lead Smelter (ASARCO)-East Side

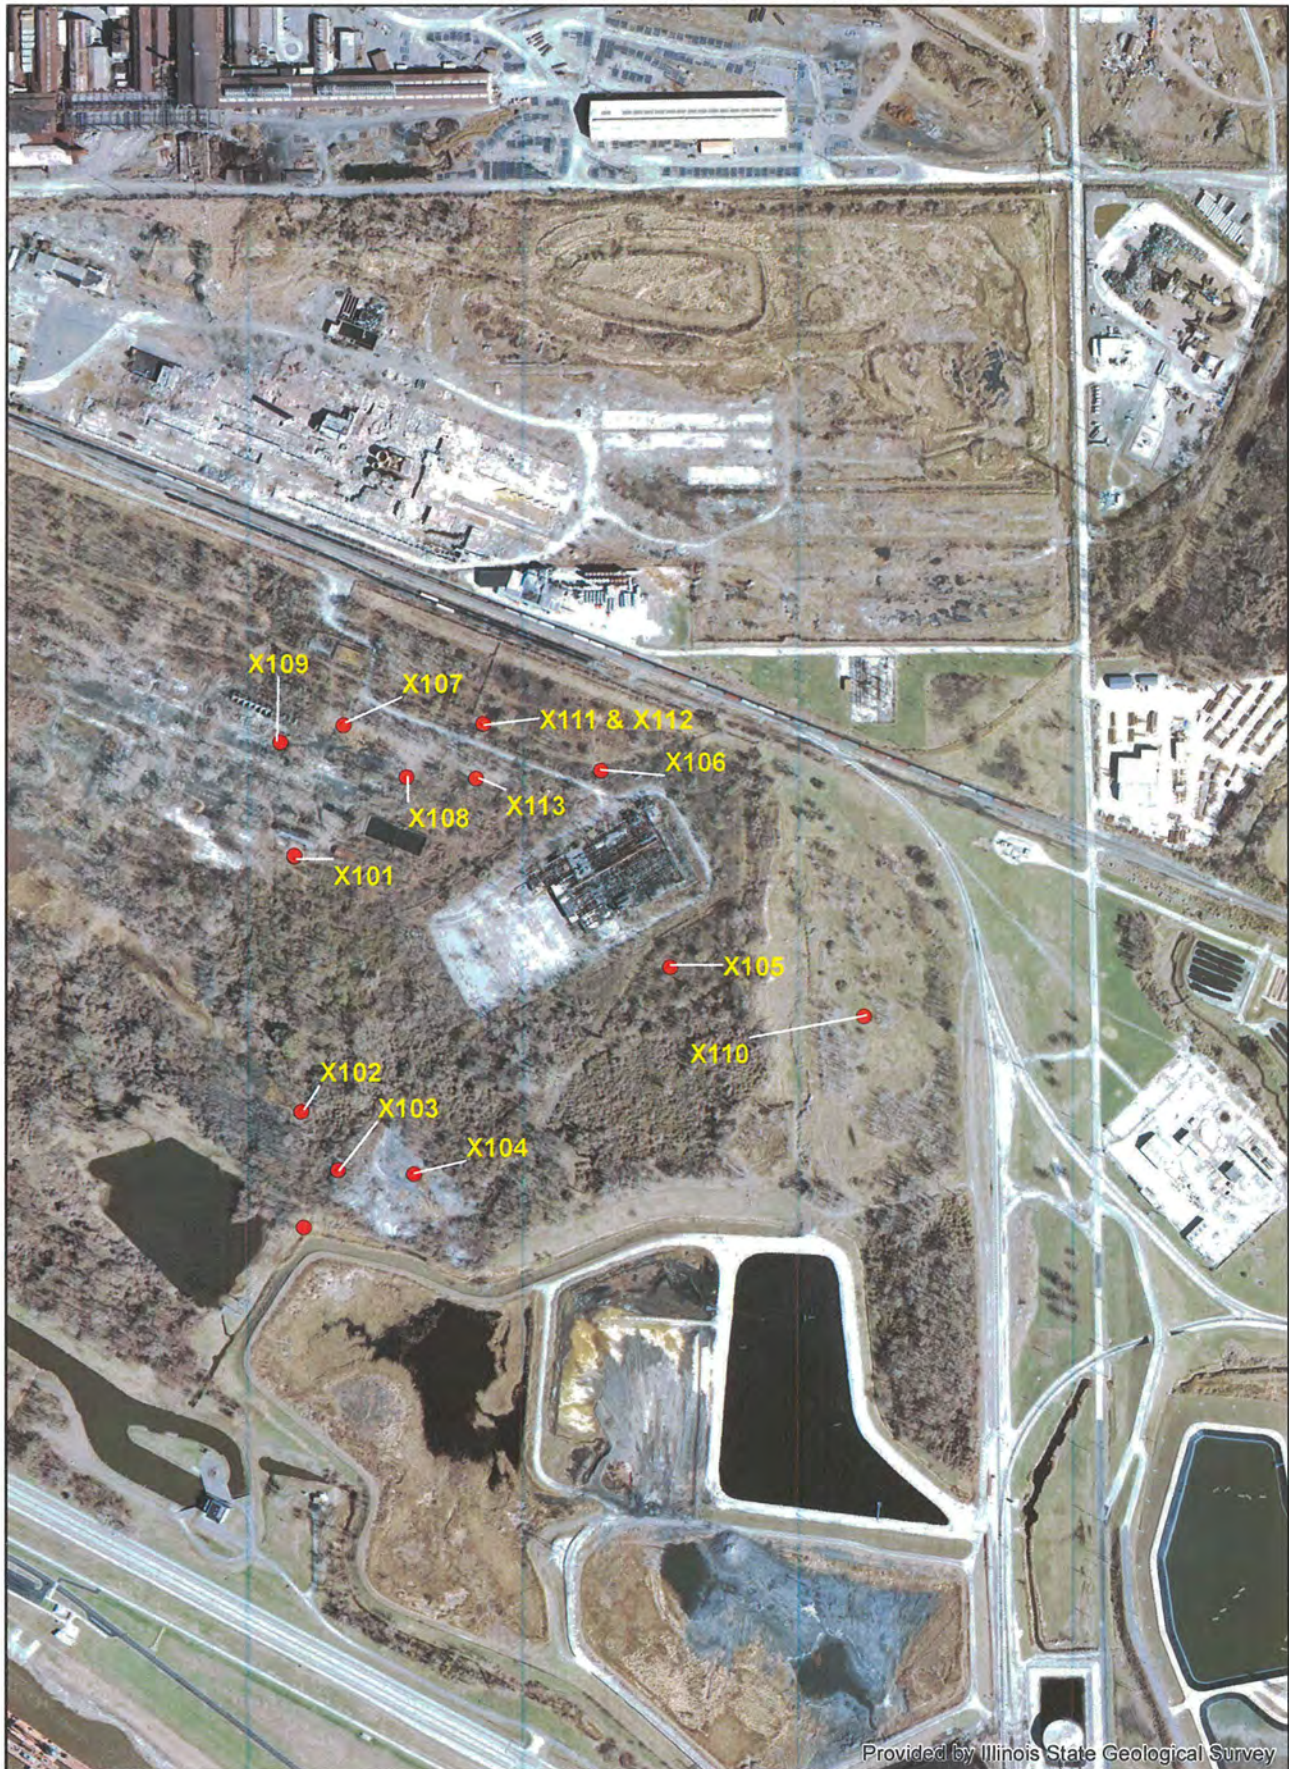
Figure2
Soil Sample Locations
Federal Lead Smelter-East Side

An intermittent unnamed drainage ditch receives runoff from the South Slag Pile and the North Slag Pile. Observed contamination was identified on the South Slag Pile at sample X103 and X104 and the North Slag Pile (Figure 2) at X101, X106-X109, and X111-X113. The overland flow for the South Slag Pile (Figure 2) is located directly below the pile as the unnamed drainage ditch is located adjacent to the South Slag Pile (Figure 6). The overland flow for the North Slag Pile is defined by the slope in topography from the North Slag Pile to the retention pond and unnamed drainage ditch. The unnamed drainage ditch and retention pond are

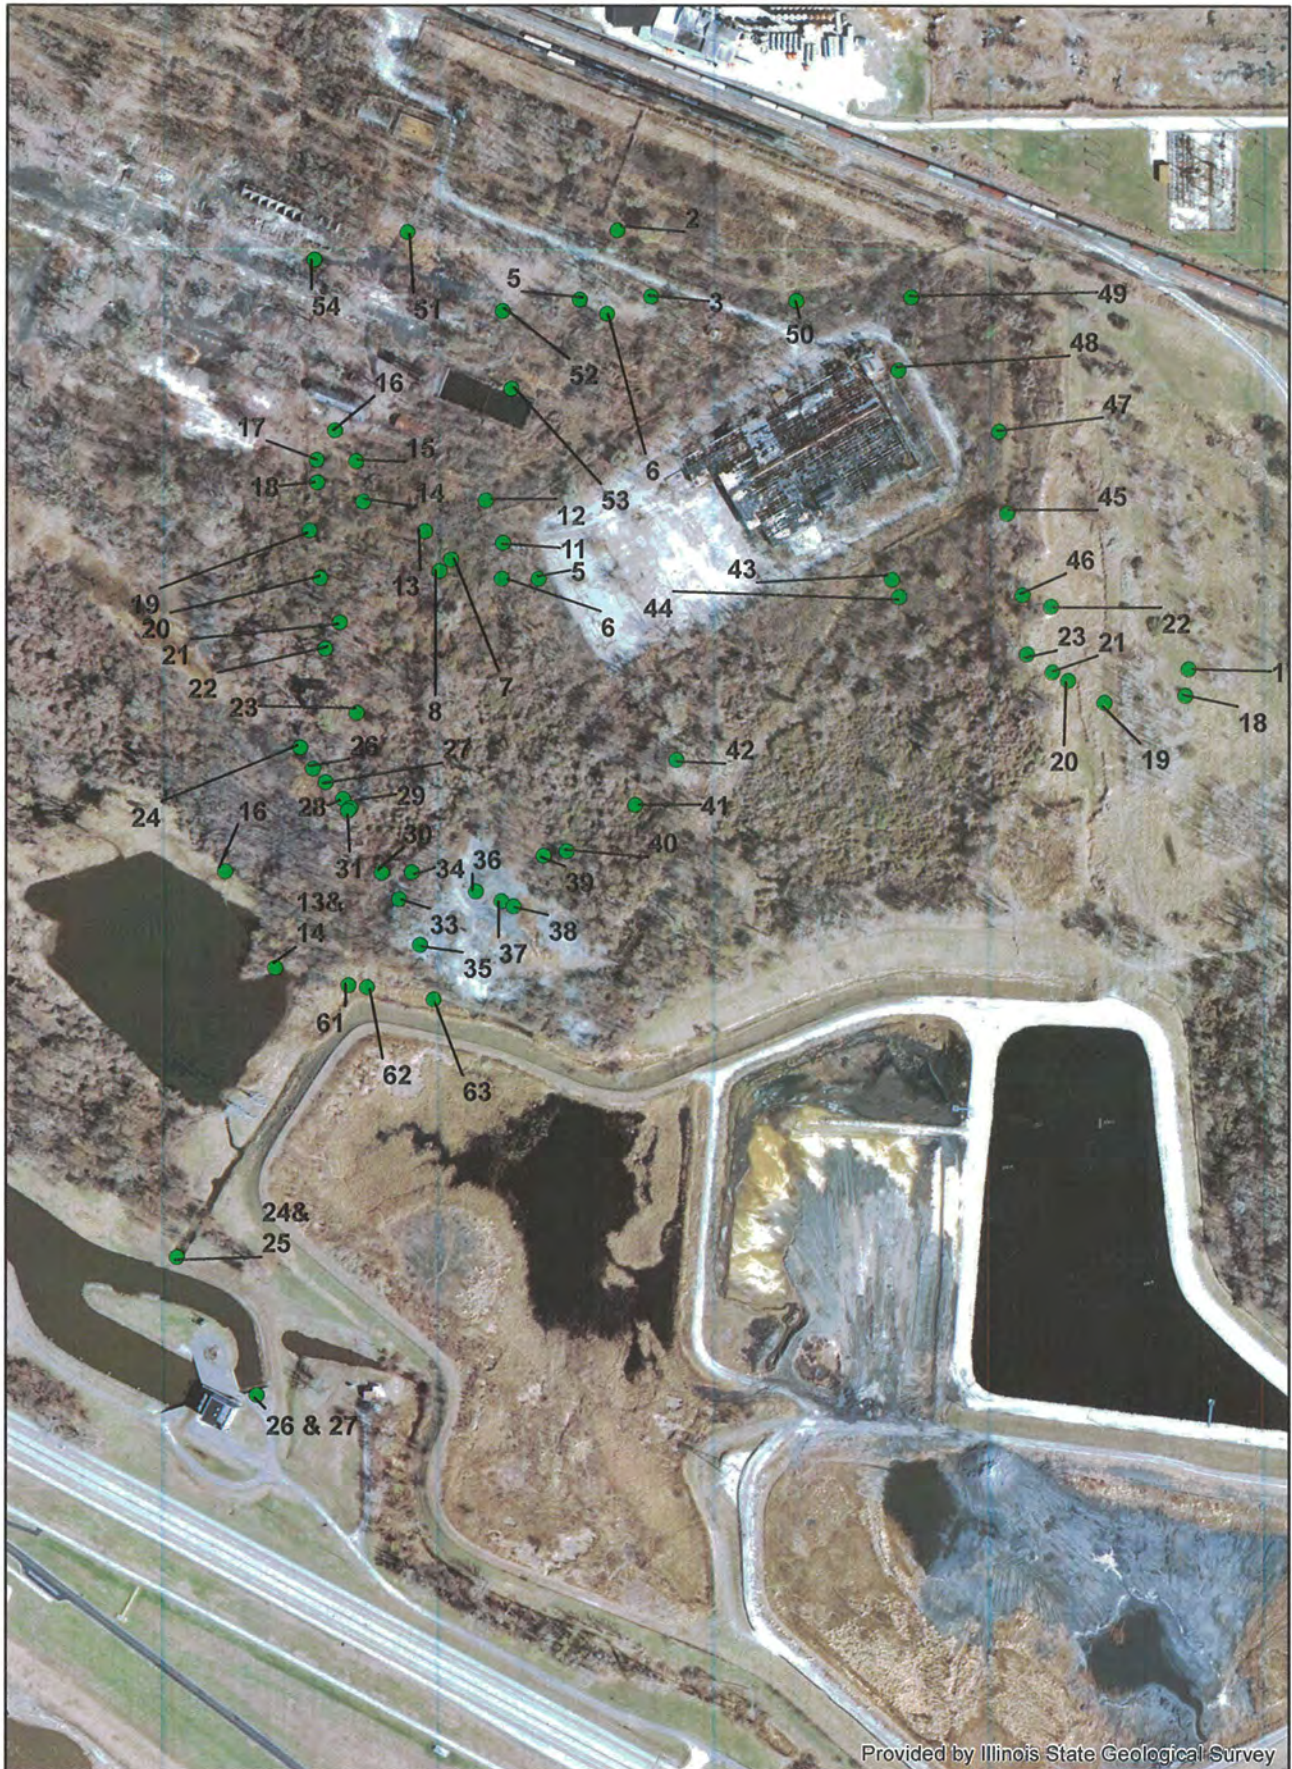
Figure 3
XRF Locations

Figure 3 illustrates the results of the TCLP samples collected from the site. Sample T101 failed TCLP analysis for lead and indicates that the waste associated with Federal Lead Smelter – East Side is characteristic hazardous waste.

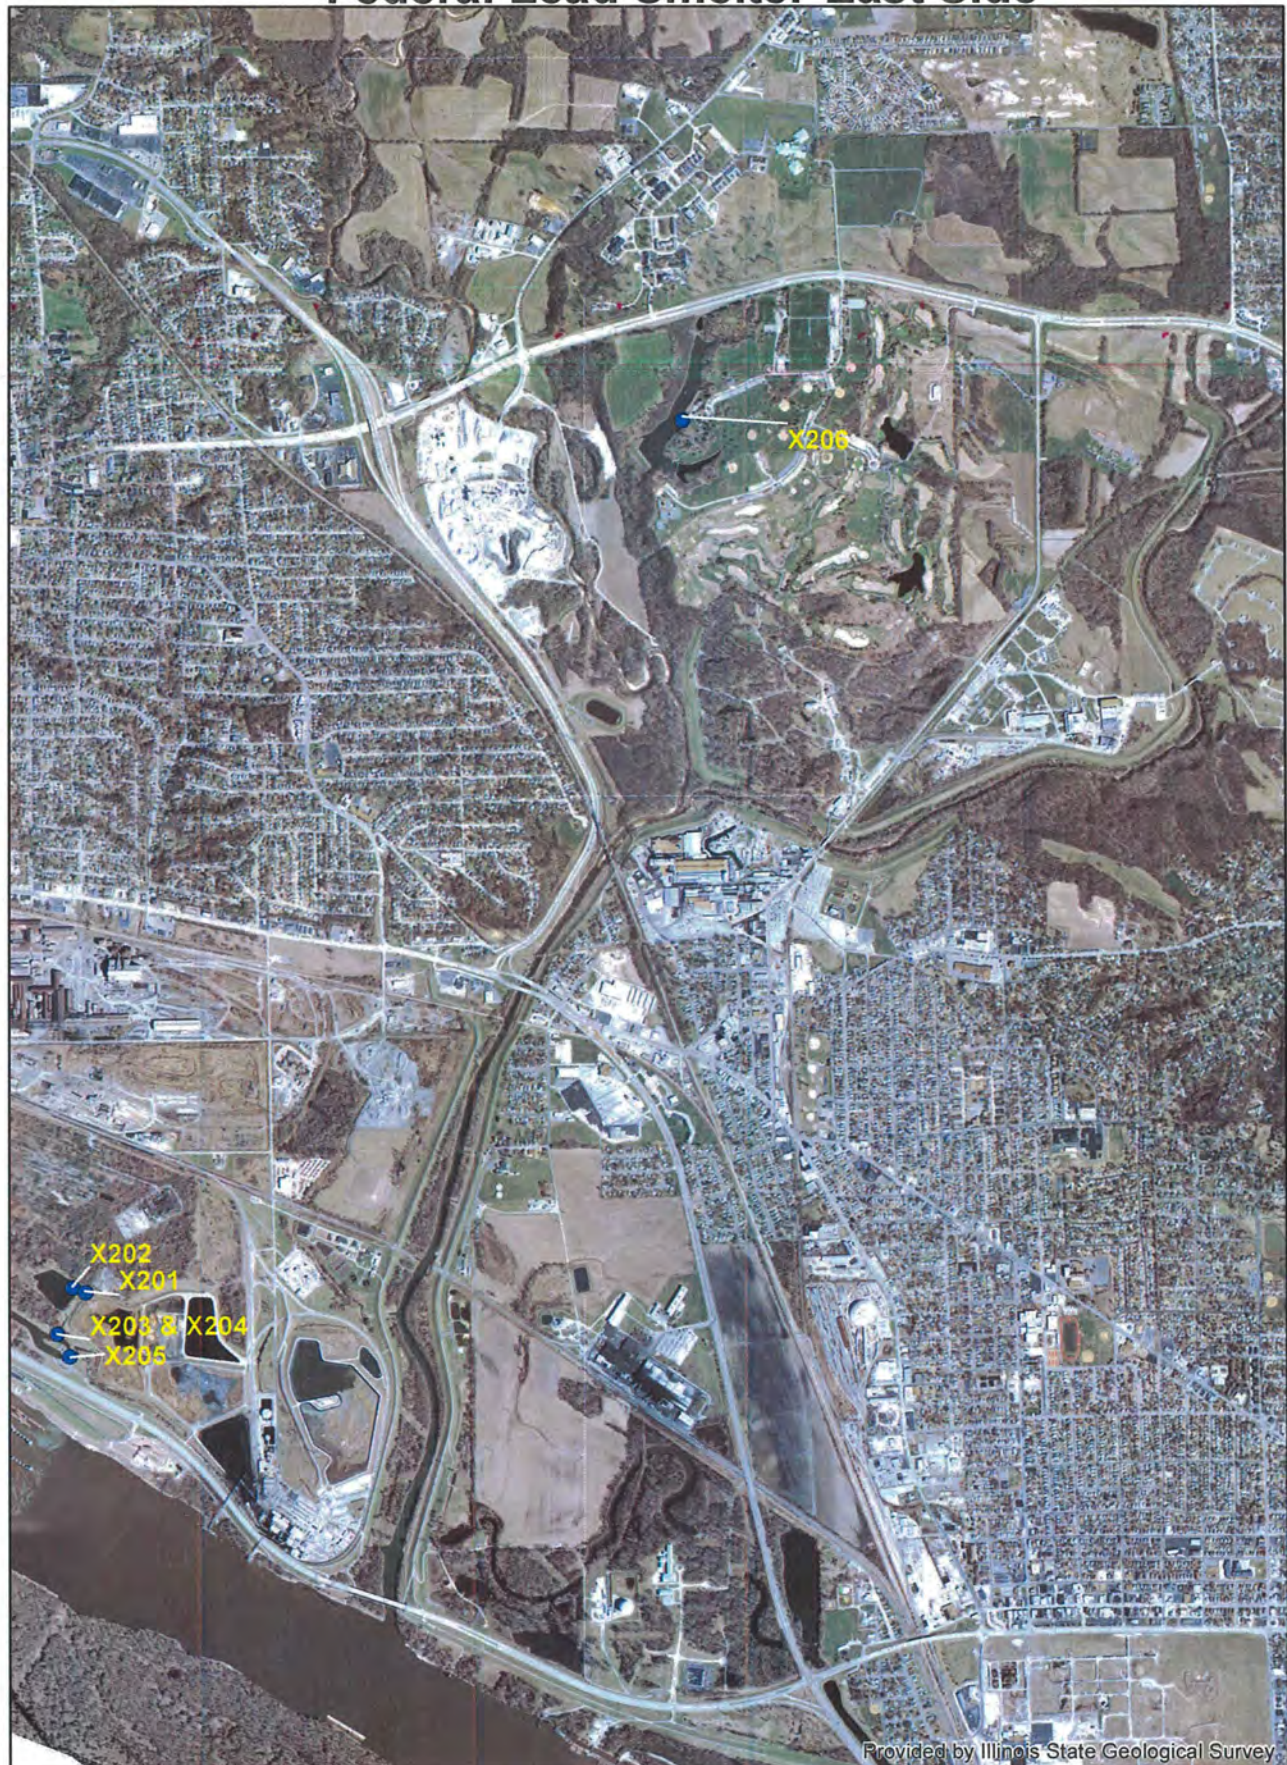
Figure 4
Sediment Sample Locations
Federal Lead Smelter-East Side

were collected using a stainless-steel auger and pan and deposited into a clear 16oz jar and then placed into a cooler with blue ice. All sediment samples were collected from 0-6 inches in depth. Sediment samples were analyzed for total metals and PCBs. Tables 2 and 5 contain the lab data associated with each sample and table 11 has a description of each sediment sample collected. Figure 4 and 4a illustrates the approximate location of each sediment sample.

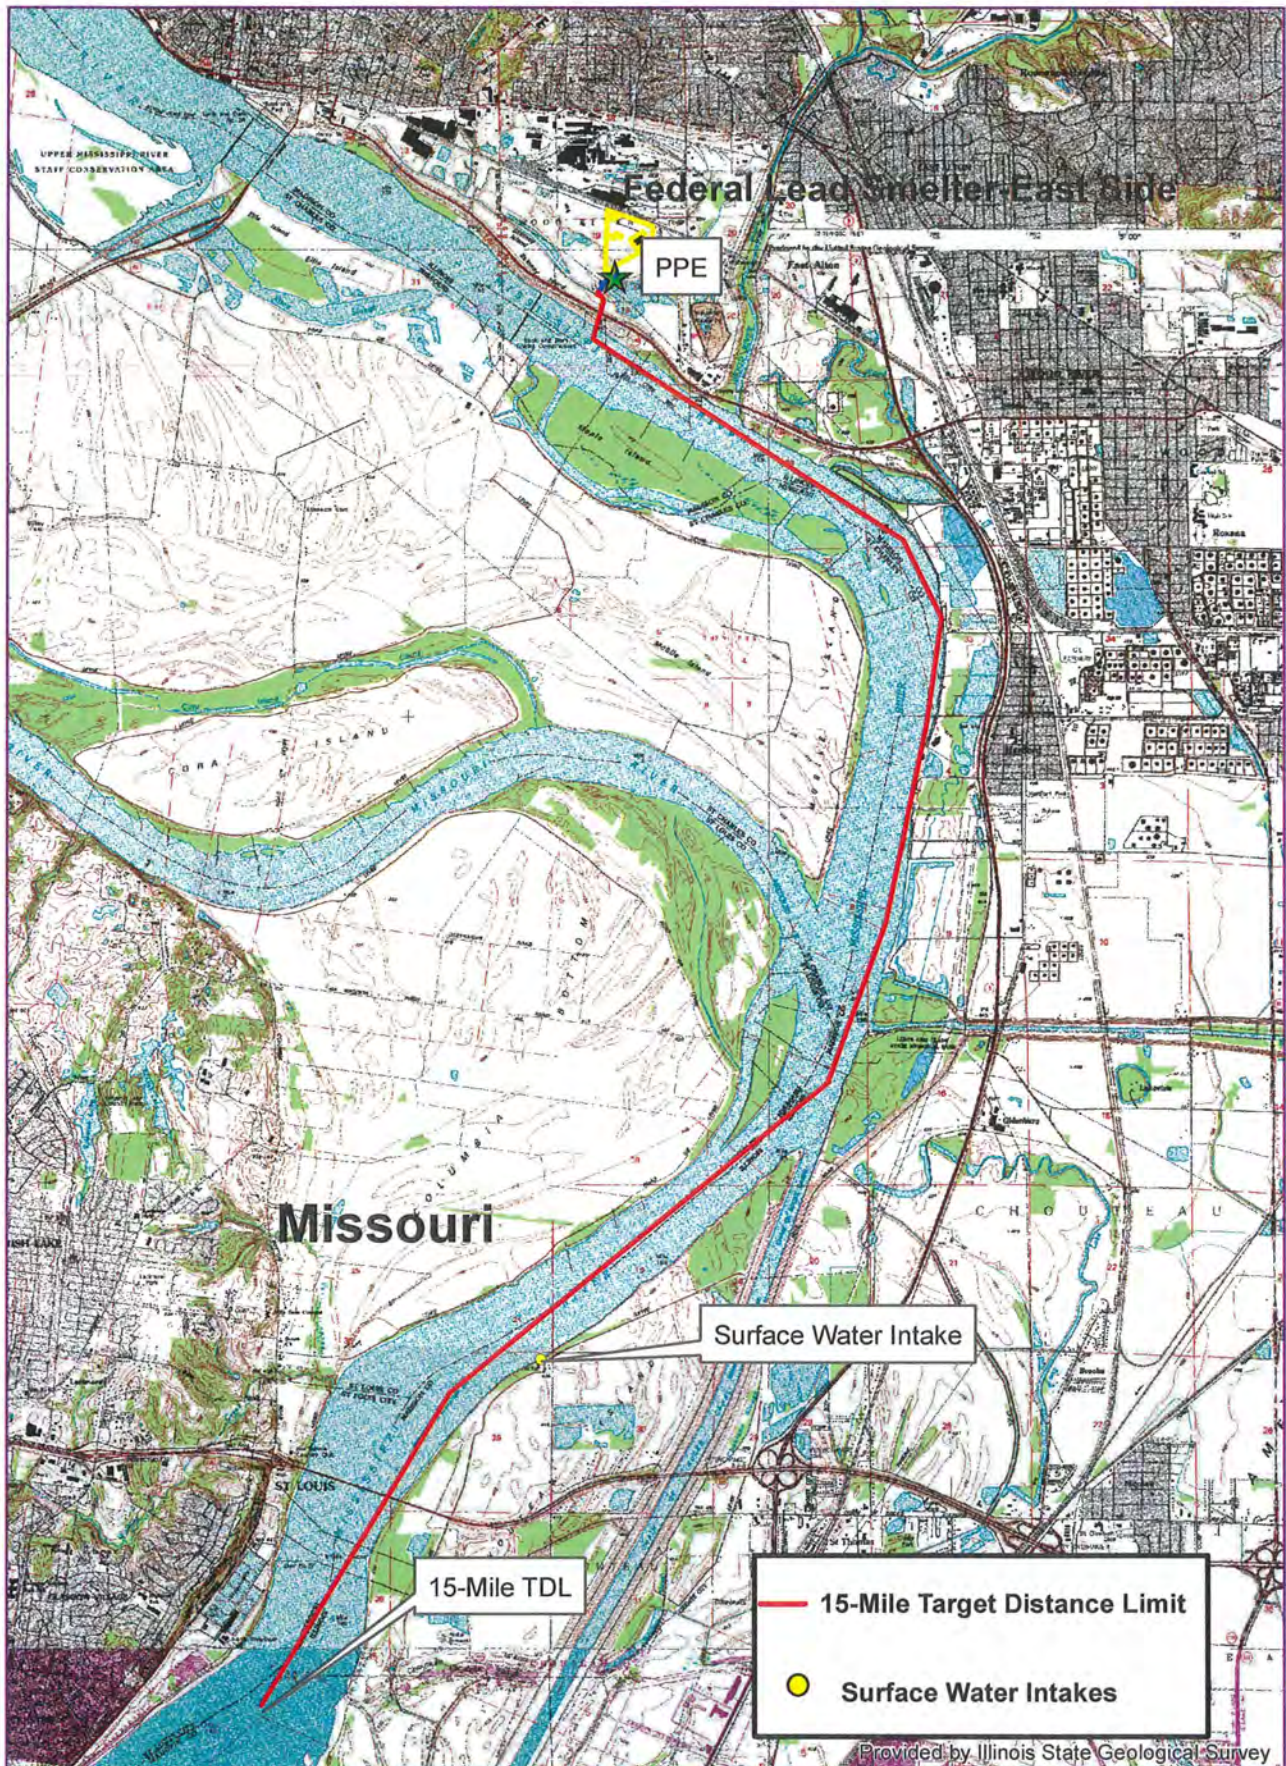
Figure 6
15-Mile Target Distance Limit

water segment and overland flow of the surface water pathway is illustrated in Figure 6. The 15-mile in-water segment included the unnamed drainage channel, retention pond, and the backwaters of the Mississippi River make up the overland flow segment of the for the site. The surface water intakes are up river of the TDL in the Mississippi River, except for the Granite City intake located approximately 10-miles downstream. Alton's surface water intakes located on the Mississippi River are located outside of the TDL.

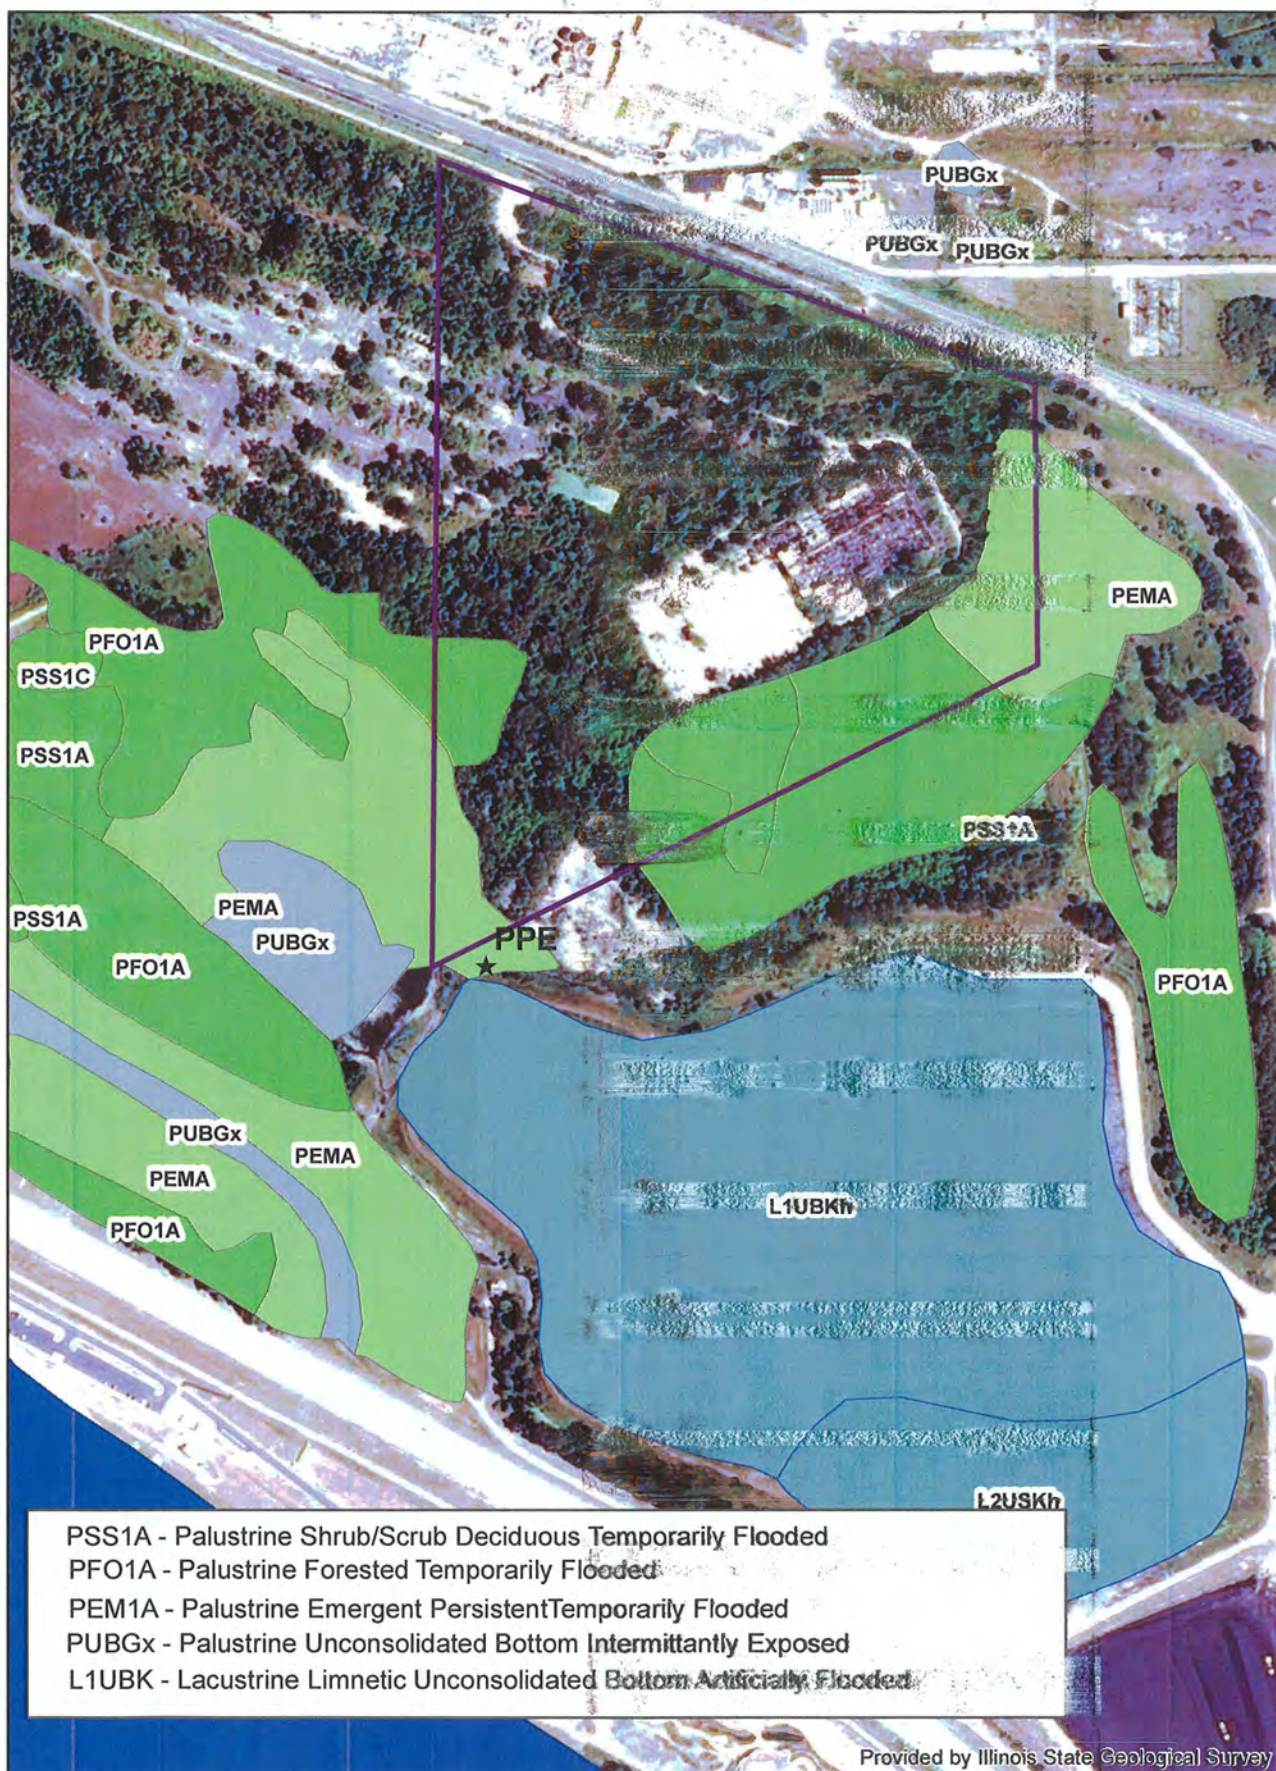
Figure 12 Wetlands Map

The National Wetlands Inventory map indicated the presence of isolated wetlands located on the site as well as isolated wetlands located just south of the property between the Mississippi River and the facility (Figure 12). These wetlands are classified as Palustrine Emergent Persistent Temporary Flooded (PEMA) and made up of approximately 484,021 sq/ft. Surface water runoff from the property interacts with the wetlands at the bottom of the slope on the south side of the property (Figure 3). These isolated wetlands are approximately 797,248 sq./ft. or 5,975 feet in distance. The nearest surface water body that would be used as a fishery is the Mississippi River located approximately 2000 feet to the south of the property. The surface water pathway is the most likely impacted especially due to the XRF readings of high lead found on the property and the presence of wetlands.

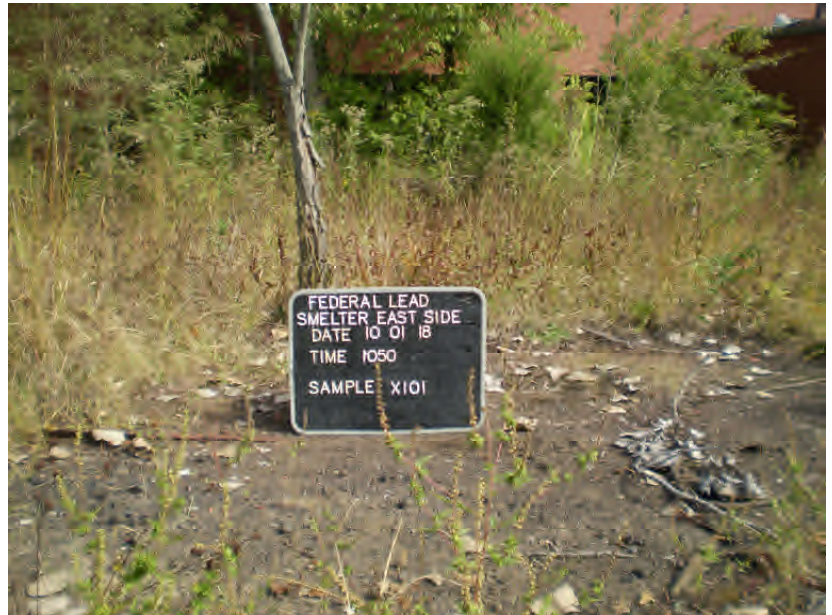
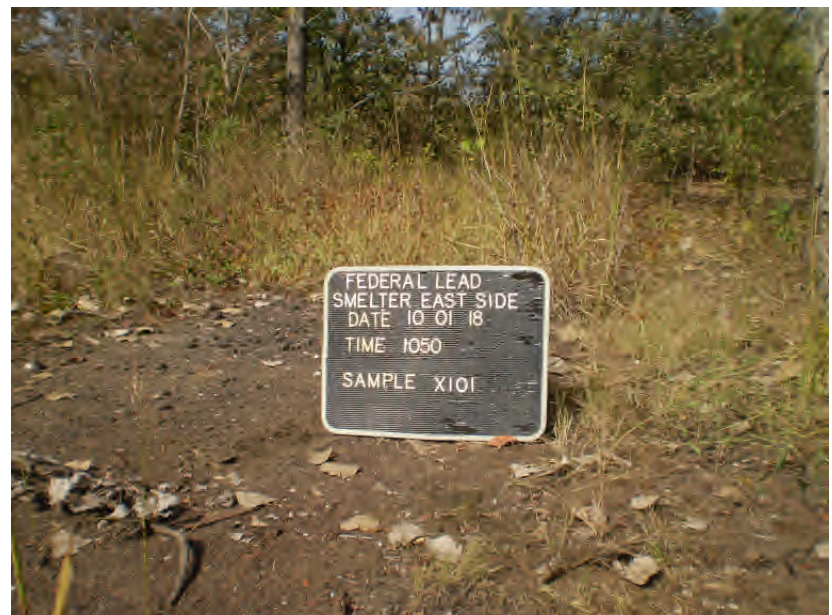
COMMENTS: X101 was collected from the surface; material consisted of slag with metal fragments and cinders; grayish brown cinder fines. Taken from south side of building structure.

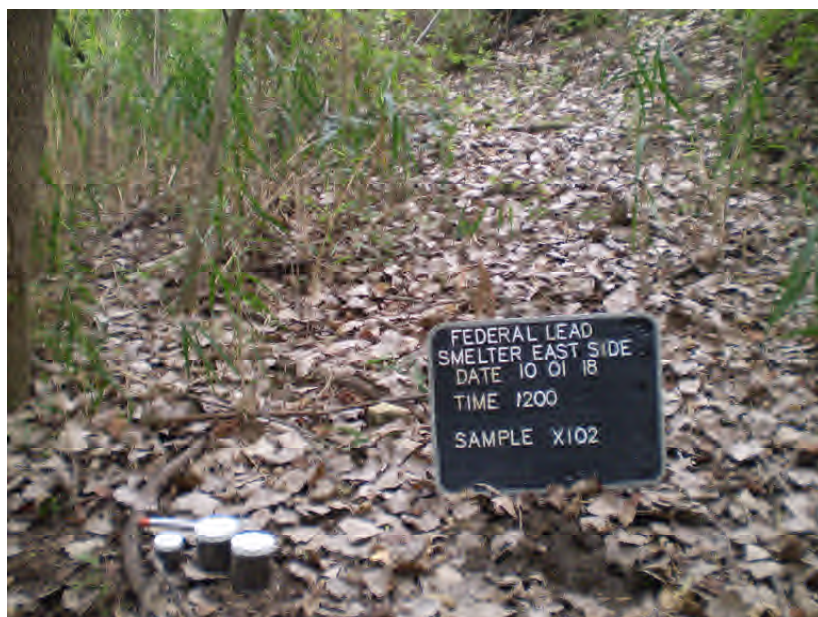
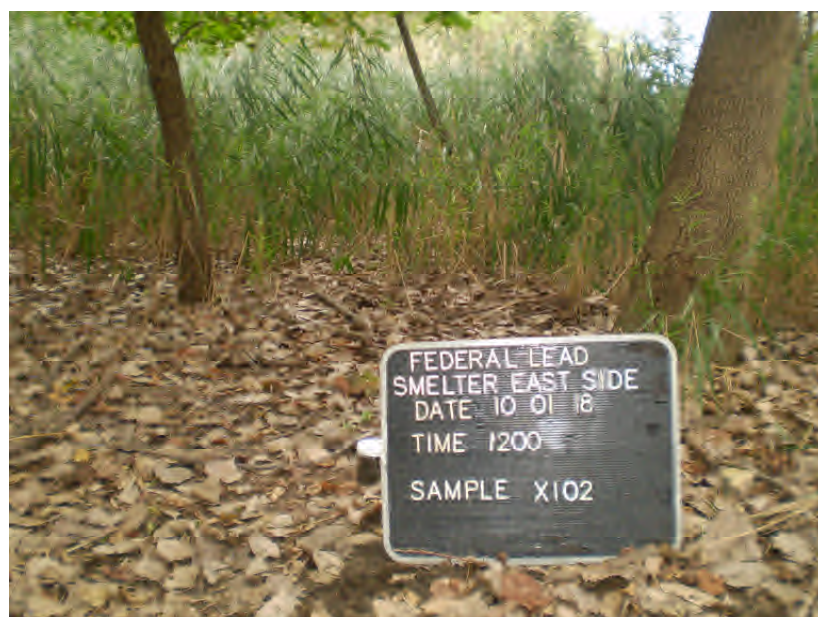
COMMENTS: X102 was collected at base of pile in wetlands. Grayish sandy material; silt.

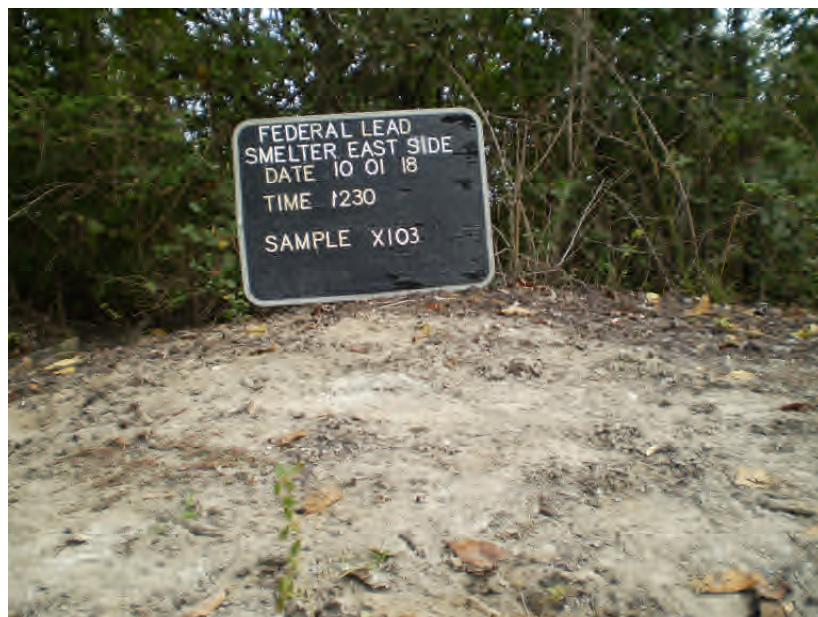
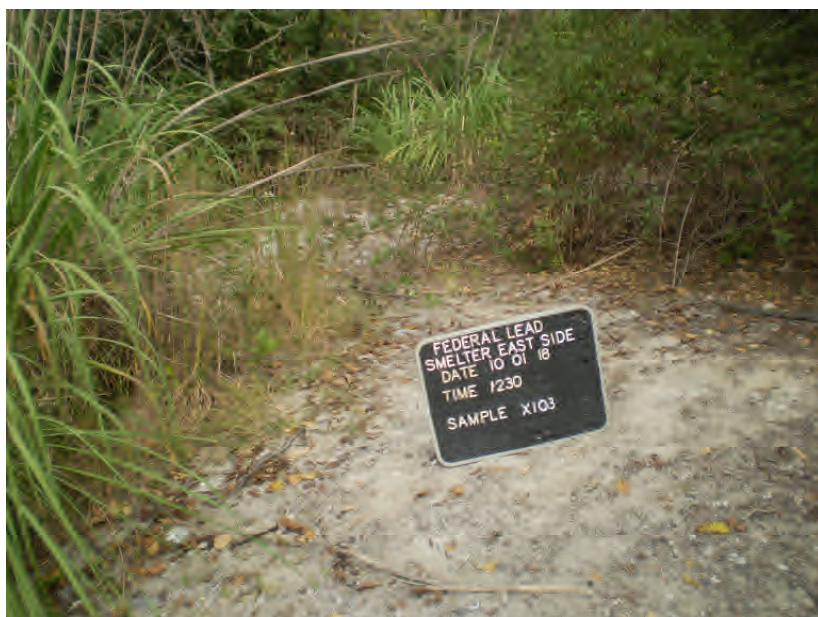
COMMENTS: X103 was collected from the surface of the waste pile located on the south end of the site. Consisted of white powdery and gray fine sandy material.

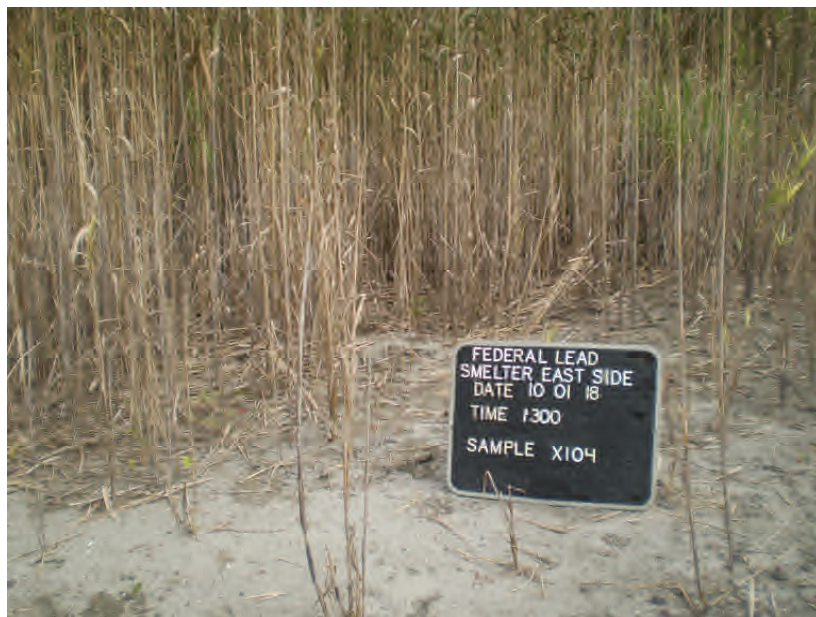
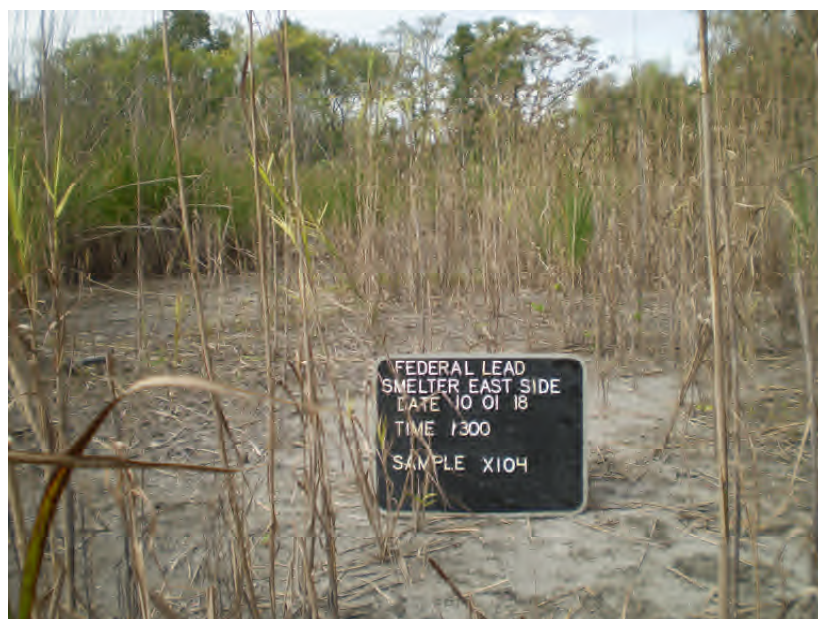
COMMENTS: X104 was collected from the waste pile and in a wetland area; gray sandy material.

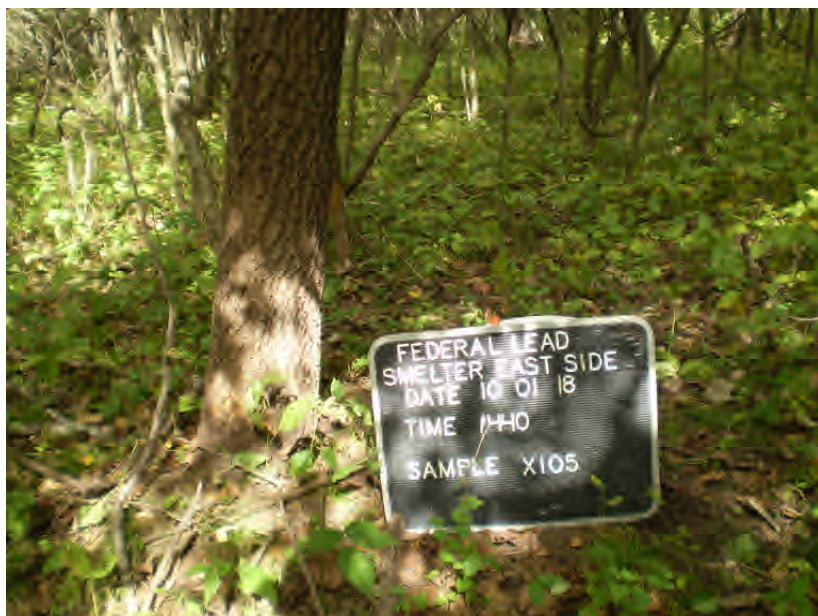
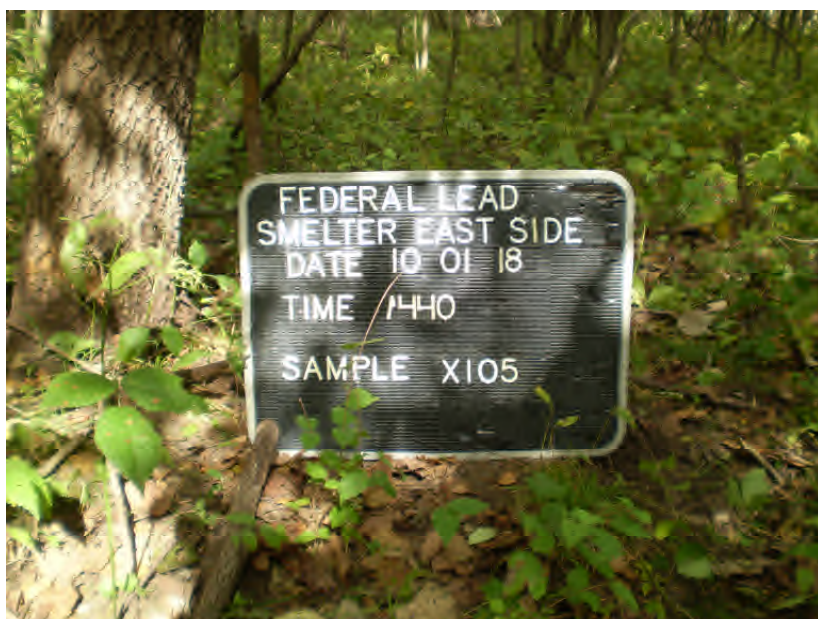
COMMENTS: Sample X105 was collected from the surface in a wetland. Soil was light brown loam.

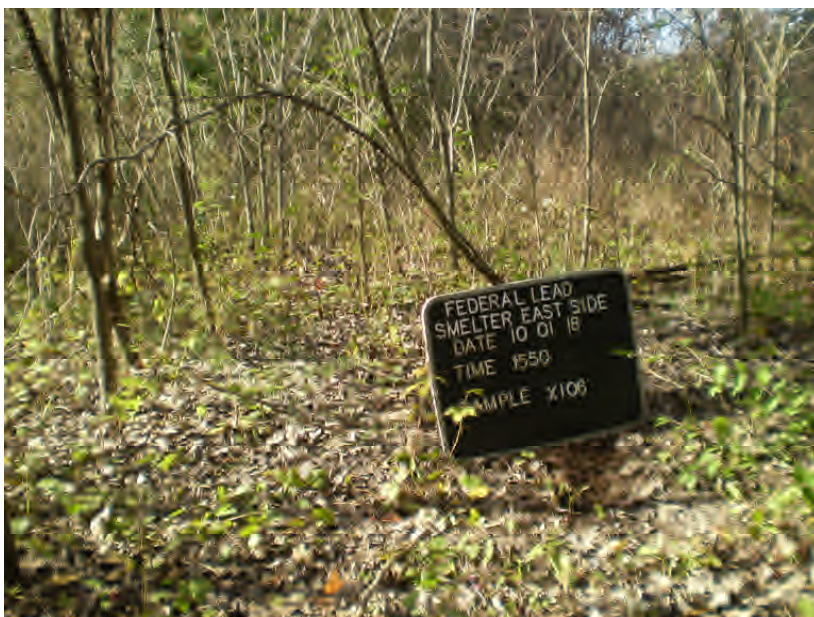
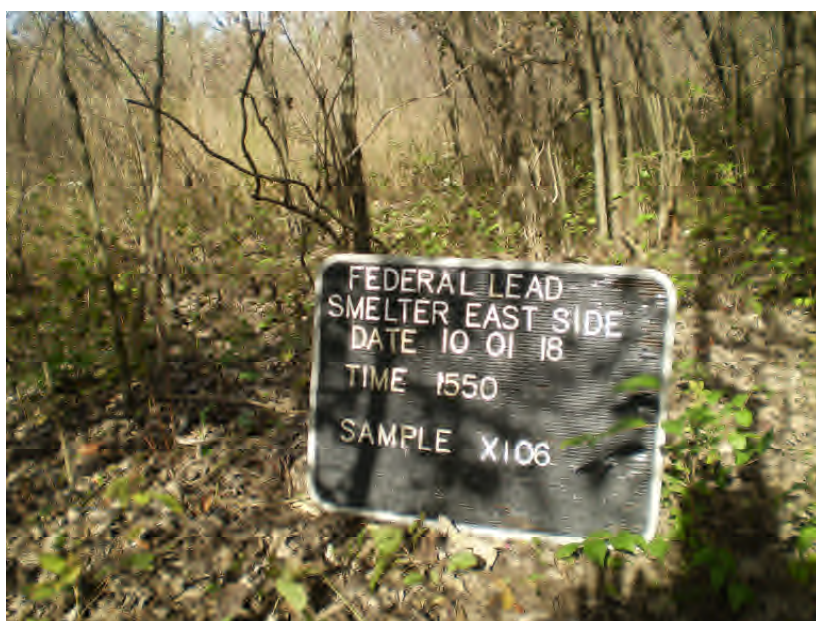
COMMENTS: X106 was collected from the surface. Consisted of fine silt and trace cinders. Low % of slag material.

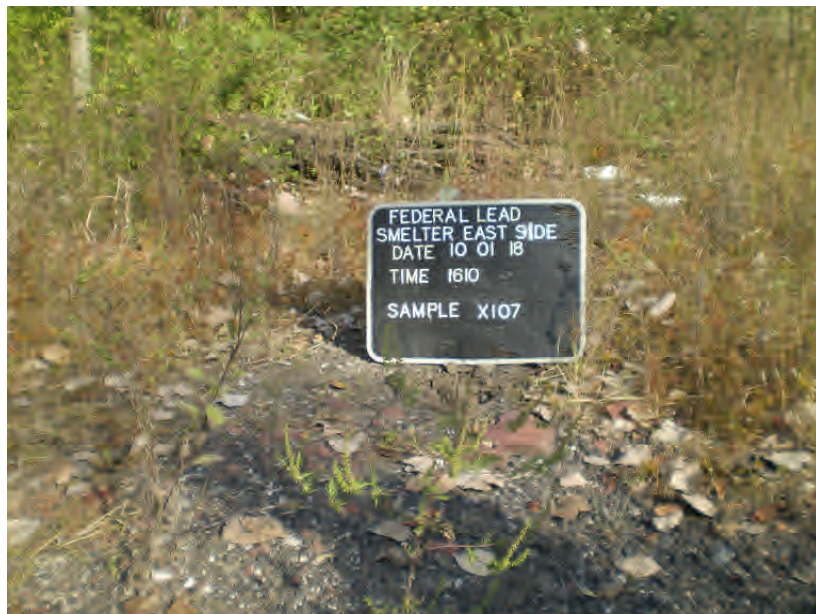
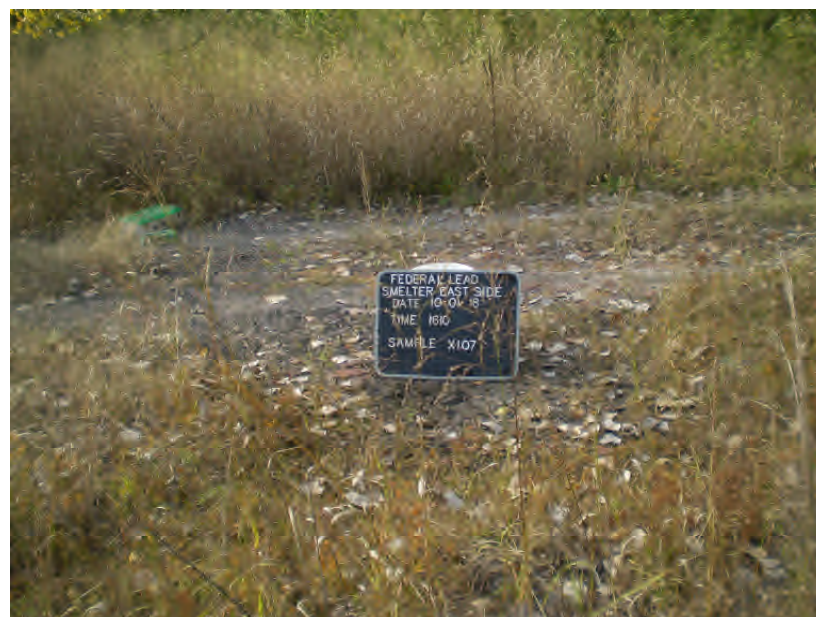
COMMENTS: Sample X107 was collected from waste material that consisted of brick shards, fine gray sand with small chunks of slag material.

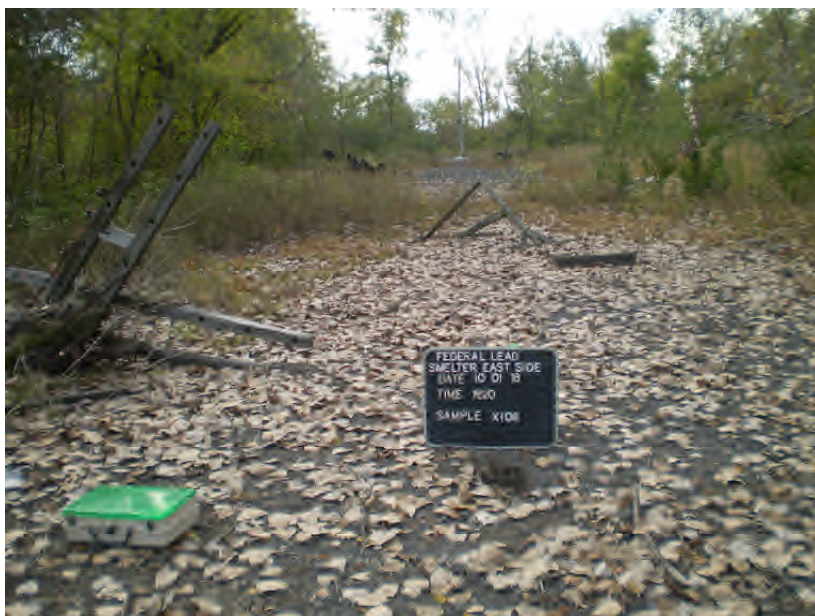
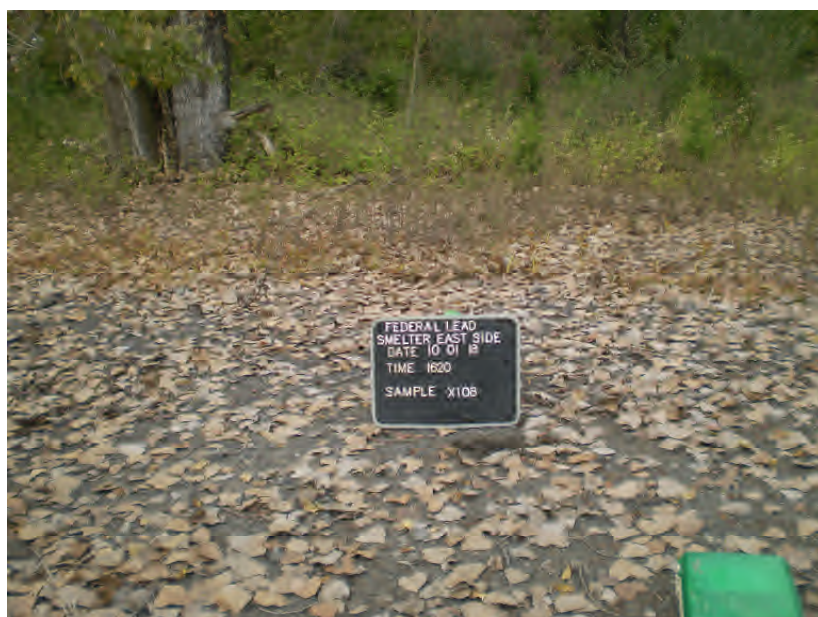
COMMENTS: X108 was collected from 0-2 inches and consisted of light gray sandy material with small chunks of slag.

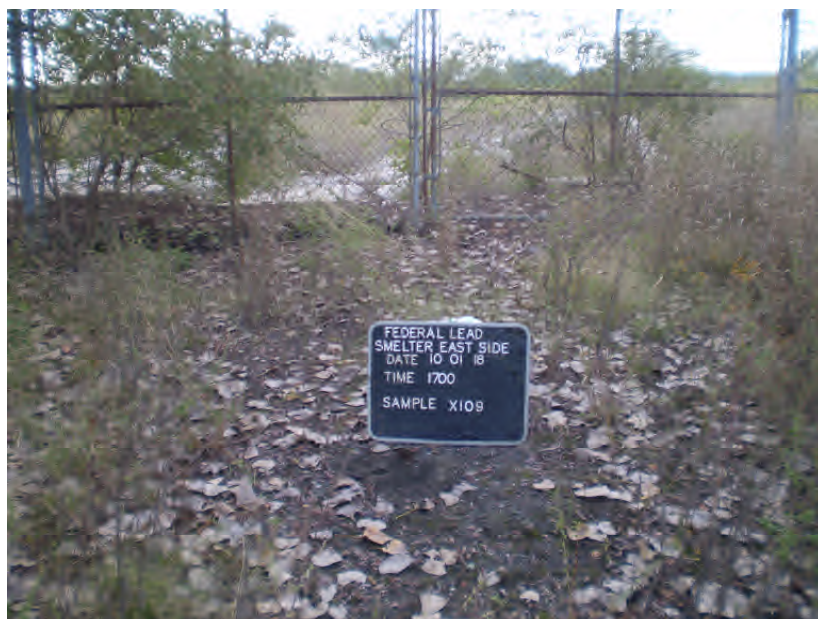
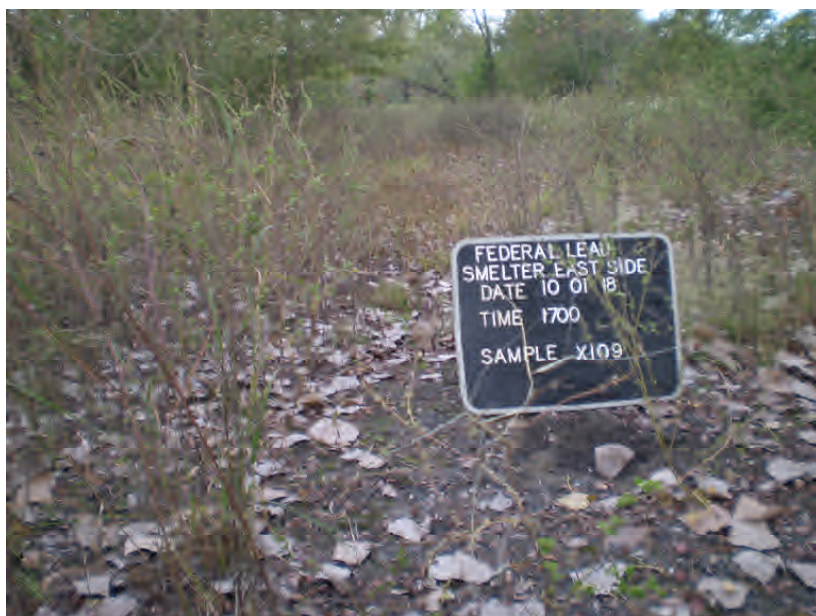
COMMENTS: X109 was collected from 0-2 inches from light gray sandy material with small chunks of slag and brick shards.

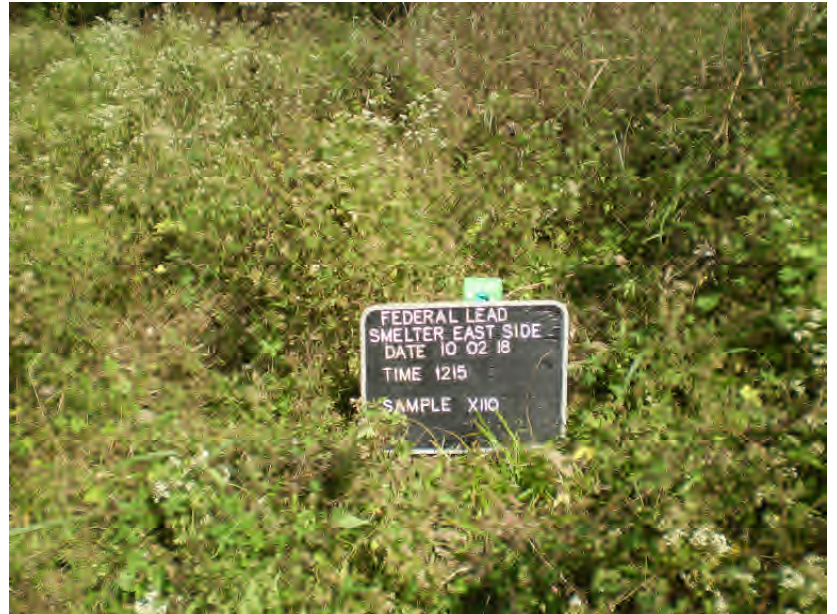
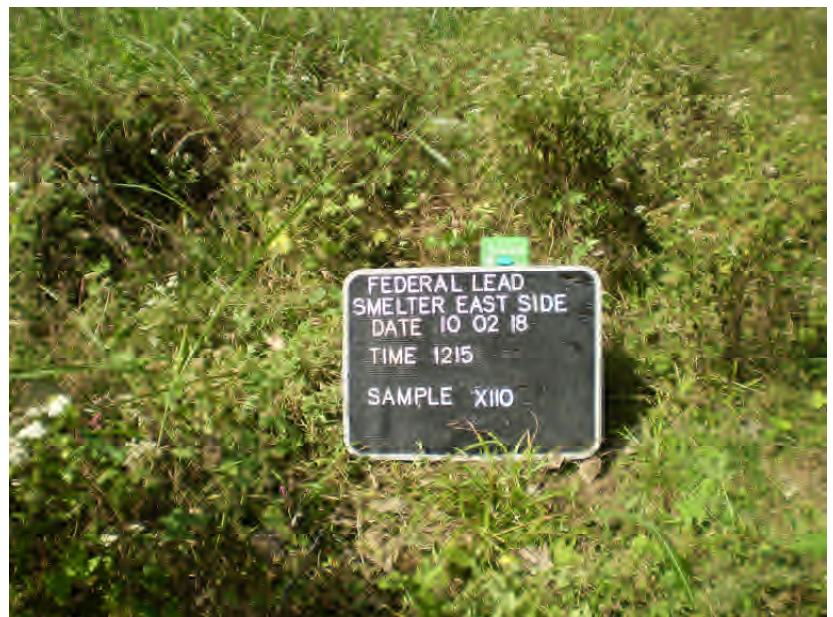
COMMENTS: Sample X110 was collected from 0-2 inches. Light brown loam with low % clay. Collected the MS/MSD.

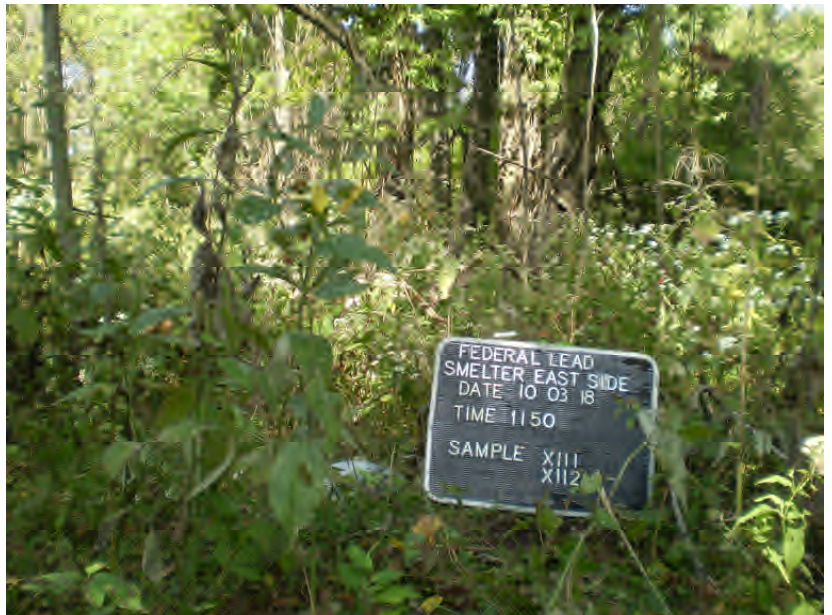
COMMENTS: Sample X111 and X112 was collected from 0-2 inches. Fine silt with trace cinders and slag material. X112 is a duplicate of X111.
